## Exclusion of barn owls *Tyto alba* from a greater horseshoe bat *Rhinolophus ferrumequinum* roost in Devon, UK.

### SUMMARY

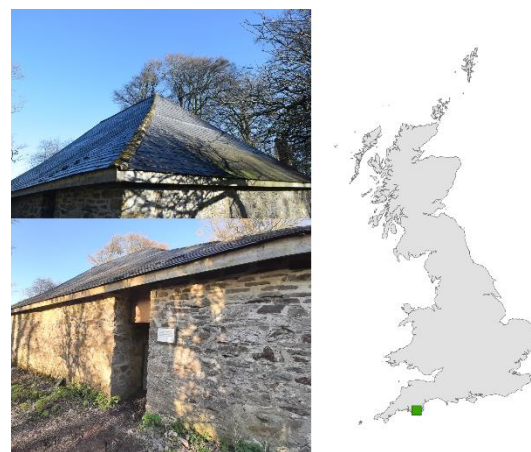
Figure 1: High Marks Barn and location.

High Marks Barn is a 19<sup>th</sup> century building with stone walls and a slate roof located in Devon, south-west England, (Fig.1), and designated as a Site of Special Scientific Interest (SSSI) because of its maternity colony of greater horseshoe bats. Vincent Wildlife Trust (VWT) acquired the barn in 1997 and carried out a series of repairs to ensure the building was weather-tight for the bat colony (Wright *et al.* 2022). In July 1997, 37 greater horseshoe bats were recorded, and numbers increased yearly, reaching a maximum of 825 adults and 360 pups in July 2017, making it one of the largest greater horseshoe bat maternity colonies in the UK at that time. However, no bats were recorded in July 2018.

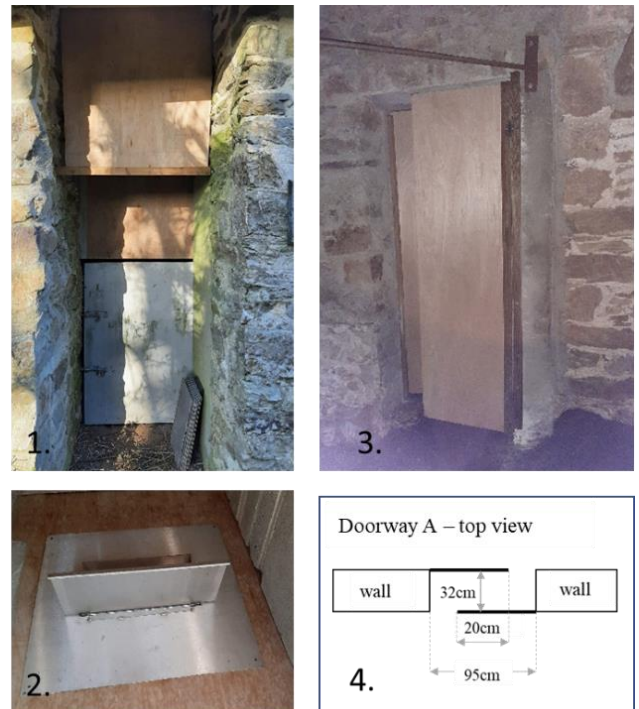
**Figure 2:** Entrance A with light baffle (1) and tip tray (2). The tip tray is a tilting tray made of 3mm thick aluminium, attached with hinges to a vertical metal sheet that forms a frame around the opening where the tray sits. The vertical metal surface (666 mm x 538 mm) and tray (390 mm x 170 mm) are smooth and prevented owls or other predators gripping the surface. Doorway A with baffles (3) and dimensions (4). Two wooden baffles were fitted on each doorway, attached to opposite sites and parallel between them, mounted on hinges to allow for human access.

Two bat entrances are present in the building. Entrance A (Figure 2) had a metal door on the bottom part and a grill at the top. The bars on the grill were 15 cm apart, which was large enough for the barn owls to access the building. Entrance B (Figure 3) is a long rectangular opening (279 cm x 27 cm) in the barn porch that provided space for bats to fly within the building prior to their emergence.

**Entrance A:** The grille that formed the top half of the door was removed and replaced by a 9 mm exterior grade plywood sheet supported on a frame made of 25 mm x 50 mm tanalised treated timber. A custom-made metal tip tray was fitted on the plywood (Figure 2) which tilts when the weight of an owl or other animal is on it, temporarily closing the opening. The default position of the tray allows the bats to fly through the opening without touching it. The dimensions of the opening were customised for greater horseshoe bats (390 mm x

190 mm). A plywood and timber baffle was fitted to the front of the tip tray to reduce light spill, rain and wind.

There are two doorways in the barn connecting room C, where the greater horseshoe bats typically breed, with the bat access points in rooms A and B. Both were modified with two plywood baffles each, attached on the left and right side of the doorway, parallel to each other and overlapping in the middle (Figure 2 & 3). The gaps left between baffles were considered large enough for the bats to access the building with ease whilst discouraging the barn owls. See Figure 2 & 3 for dimensions. The baffles were attached on hinges to allow human access and tower bolts were used to keep them in place.

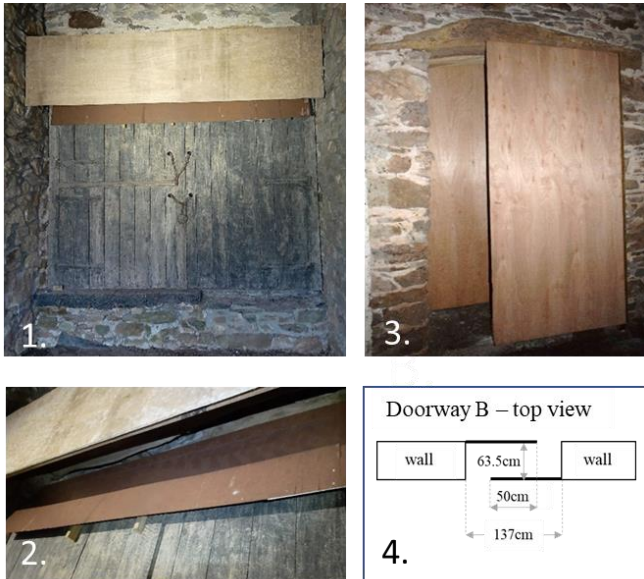
**Figure 3:** Entrance B (1) with baffle and metal tray (2) fitted as an anti-gripping surface to prevent owls perching. Doorway B with baffles (3) and dimensions (4).

**Entrance B:** A galvanised steel sheet (1.2 mm thick, 50 cm width) was attached below the opening on the outside, covering the whole length of the entrance (Figure 3). This provided a smooth surface that prevented owls and other potential predators from gripping or perching. A box made of 9 mm exterior grade plywood sheet and 25 mm x 50 mm tanalised treated timber with an open bottom was attached at the top of the entrance, on the external side, covering the whole length of the gap. The gap between the box and the wall is 38 cm, which is 10 cm wider than the widest point on the entrance (16 cm - 27 cm). The box is designed to prevent owls from flying directly into the barn, as any attempt to do so beneath the box would cause the birds to stall in flight. The steel sheet should prevent them gaining any purchase to crawl up into the building.

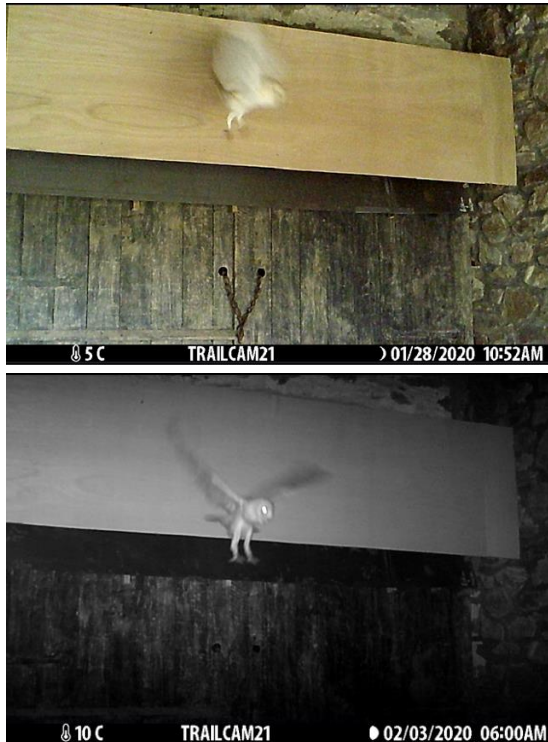
Figure 4. A. Barn owl attempting to access through entrance B on different days.

Following the modifications, the barn owls were recorded attempting to but failing to enter the building through entrance B (Figure 4). The trail camera recording entrance A had no footage of the owls. The internal trail camera and building inspections confirmed no owl presence (e.g., video footage, pellets, feathers) inside the building since the interventions took place in January 2020.

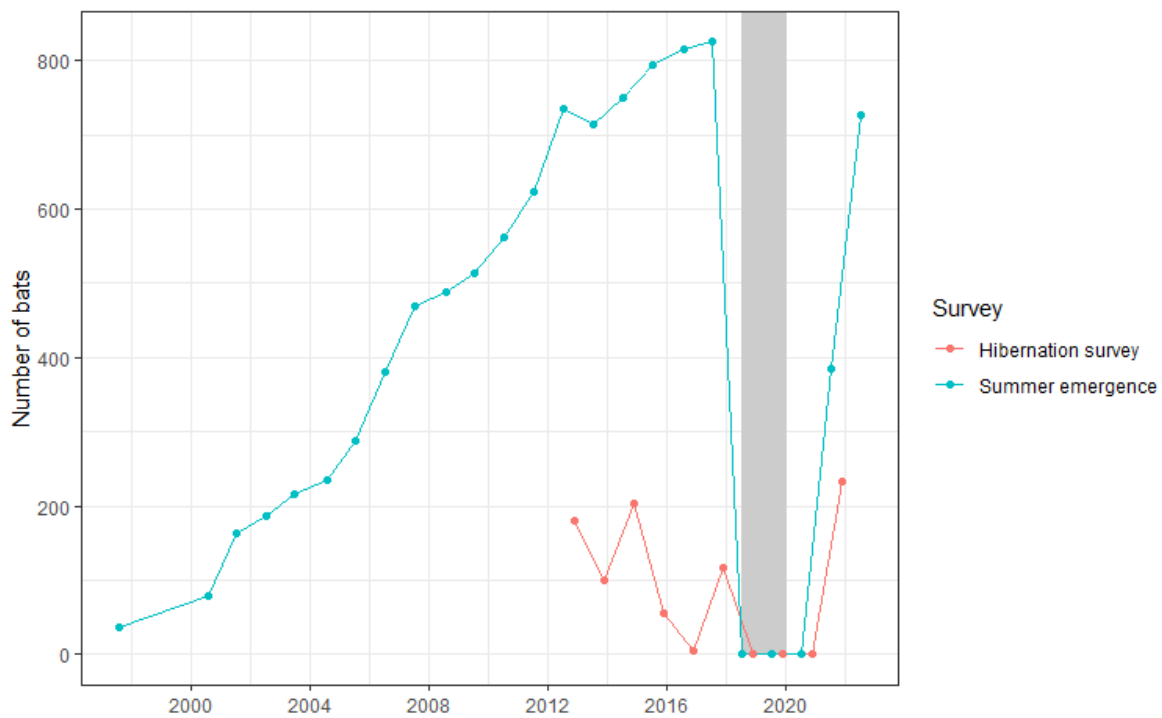
Figure 5. Maximum number of greater horseshoe bats counted during summer emergence surveys (blue) and internal hibernation counts (red) at High Marks Barn as part of the National Bat Monitoring Programme from 2000 - 2022. The grey band shows when barn owls were present.

A maximum of 825 adult greater horseshoe bats emerged in July 2017 when 360 juvenile greater horseshoe bats were observed inside the roost (Figure 5). Barn owls were present in 2018 and 2019 resulting in the absence of bats before the modifications took place in January 2020. In July 2022, 755 adult greater horseshoe bats emerged from both entrances (92% recovery of the count before barn owls moved in), and 335 juveniles were

recorded in the roost which is 25 fewer than the highest count in 2017 (see Figure 5).
