Use of a remote camera to rapidly assess Eurasian badger *Meles meles* occupancy within a sett to be lost due to pipeline laying near Uppingham, Rutland, England

Senior Ecologist, Mott MacDonald, Demeter House, Station Road, Cambridge CB1 2RS, UK

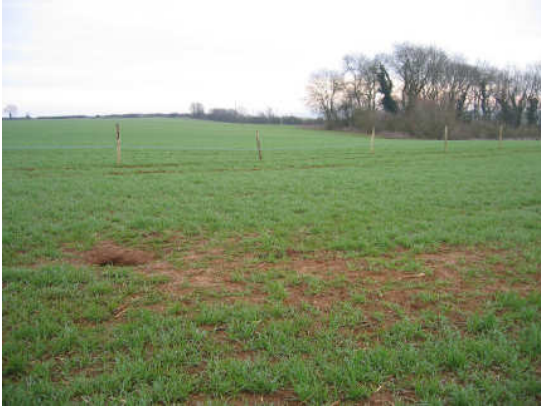
Despite surveys of the pipeline route and change of alignment to avoid known setts, a one-entrance badger sett was identified at a late stage of the project (late January 2008) within the area required for trenching and pipe installation. This sett, considered to be an outlier sett (sett definitions follow Neal & Cheeseman 1996), was located near the town of Uppingham in Rutland in the centre of a large arable field (Fig.1) which was not accurately surveyed prior to the works as disturbance and damage to the crop would have been caused.

Figure 1. Outlier badger sett (left side of photo) in the arable field within the pipeline easement.

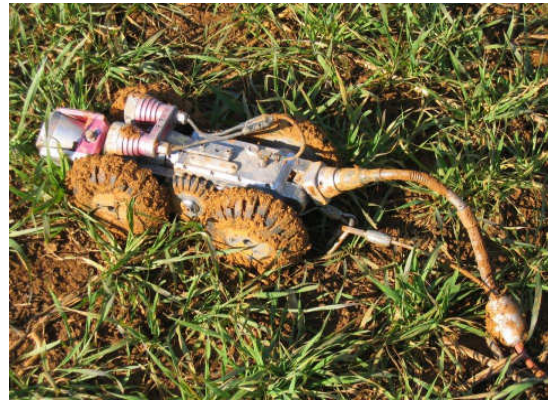
Remote camera observations: Instead of further lengthy monitoring of the sett and potential delays to the pipe installation programme, an alternative solution was proposed. A licence was obtained from Natural England to observe the inside of the sett using a remote camera. On 13 February 2008 a wheeled, remote controlled device with a pan and tilt camera (connected by a wire cable to a nearby van installed with a close circuit television (CCTV) unit) was sent into the badger sett (Fig. 2). Present at the site were representatives from Mott MacDonald Ltd. (consultant), J.N. Bentley Ltd. (pipe-laying contractor), Natural England (SNCO) and the two CCTV operatives.

Figure 2. Remote camera device used to explore the badger sett.

During this time a hand-held, cable avoidance tool (C.A.T scanner) was used to detect the direction of camera movement within the tunnel from above ground. The camera device calculated the distance travelled into the sett as well as providing live images of the tunnel.

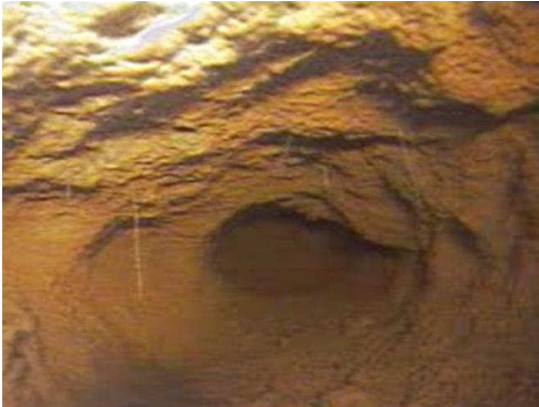
The pan and tilt facility enabled identification of any potential forks leading from the main tunnel. The camera provided very clear images (Fig. 3) which were viewed on a wide screen TV monitor in the vehicle.

The use of the remote camera proved to be a practical solution. The inspection (lasting approximately 1.5 hours) gave good evidence that the sett was not currently occupied. There was not 100% certainty that the sett was empty as despite the camera having a pan and tilt facility which provided 360 degree visibility,

uneven ground meant that not every dark shadow could be fully explored.

Figure 3. Still image from video footage taken by the remote camera of the badger sett tunnel.

The sett structure was found to be simple, with one main tunnel of 5.6 m long. One branch to the tunnel was found. This was also explored using the camera. No evidence of bedding or occupation by badgers and / or badger cubs was found. Despite signs of recent digging, the tunnel did not widen into a sleeping chamber at any point. This allowed the sett to be immediately taken apart using an excavator as specified under the terms of the Natural England licence.

Once the sett was taken apart and the area back-filled, the ground was proofed using heavy duty chain-link fencing to prevent re-entry by badgers. This area was subsequently further monitored by ecologists until the pipe was laid
