Adder *Vipera berus* hibernacula construction as part of a mitigation scheme, Norfolk, England

A significant adder, *Vipera berus*, population was identified within the Upper Thurne river catchment during baseline surveys in 2009. An adder bank (hibernacula) was constructed in the autumn 2009 in advance of flood defence works at Horsey in 2010 to mitigate any temporary loss of hibernation and natal den sites. Reptile fencing was erected around the adder banks and some adjacent grazing marshes in February 2010 to create reptile enclosures. During March to May 2010, 119 adders were moved to the adder banks from the flood banks that were then stripped of vegetation and topsoil to discourage animals from re-entering the working corridor. Sections of the adder fencing were removed in mid-May to allow animals to disperse to their summer foraging grounds. Surveys during summer 2010 indicated breeding success within the banks. Pre hibernation surveys in 2010 recorded a peak count of 22 animals, and a spring emergence survey of the adder bank in 2011 identified 17 individual adders. A further four were recorded using an adjacent store of rush, *Juncus*, bales. Monitoring through summer and

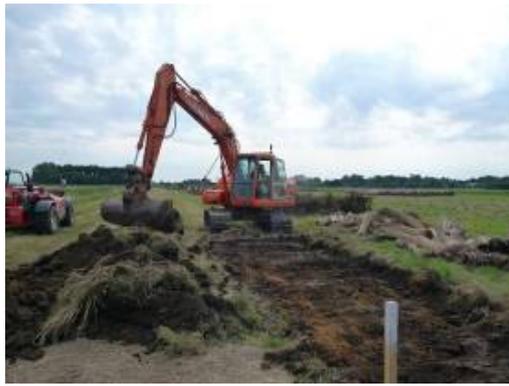
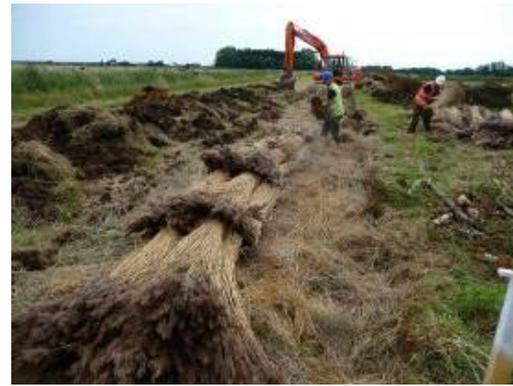
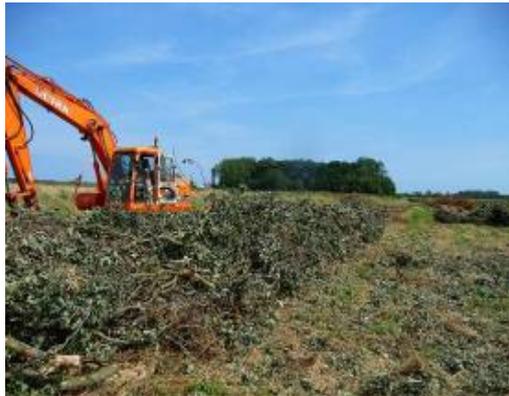
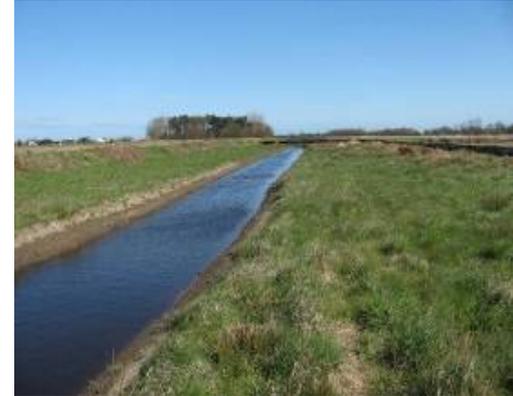
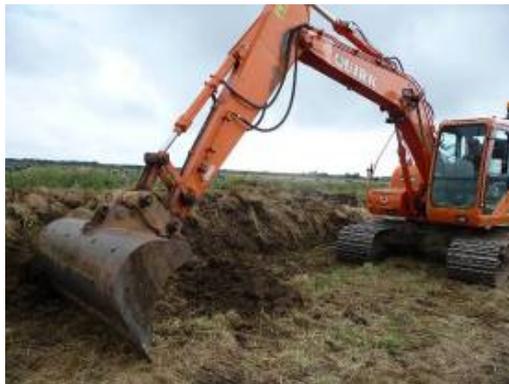
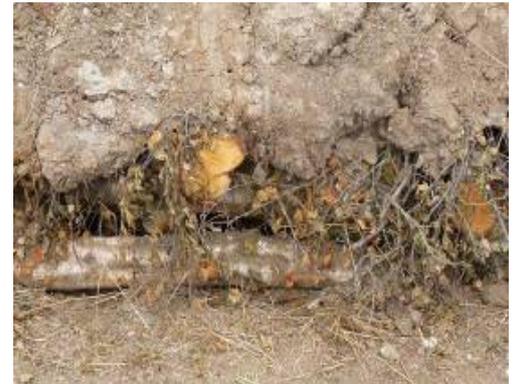
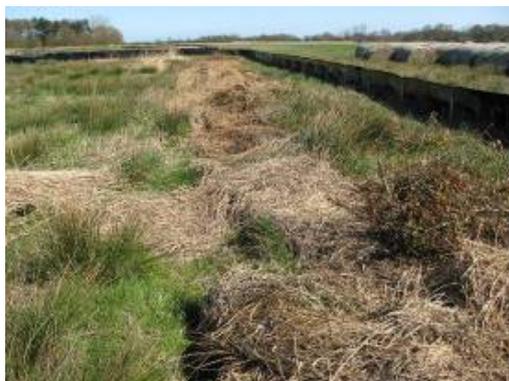
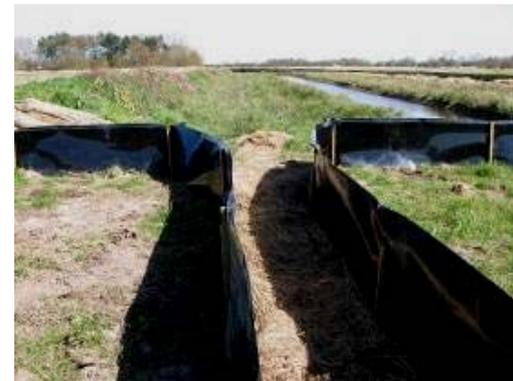
Figure 4. The creation of the hibernaculum (a) vegetation and topsoil stripping; (b) rush round bales (unrolled) and reed bundles to create a central core; (c) timber logs and brush placed over the central core; (d) shallow dykes excavated parallel to the adder banks to provide spoil to cover the banks; dykes vegetated quickly and provide ephemeral habitat for amphibians, invertebrates etc.; (e) excavator trimming the south facing bank to expose brush and reed bundles to provide access points; (f) access points into the adder bank provided by brush, timbers and reed bundles along the edge of the bank; (g) habitat piles within the grazing marsh to provide cover and areas to bask; (h) adder enclosure and an 'Adder bridge' constructed over a marsh dyke to connect sites.

The footprint of the adder banks and the borrow dykes were marked out using a Trimble GPS. The turves and topsoil were then stripped (Fig. 4a) and stored for use on the bank once the structure was constructed. Rush bales were unrolled to create a 30 cm depth of straw. Reed bundles (laid longitudinally) were then placed on top (Fig. 4b) to create a central core to the bank. Logs were placed over the central core and covered by brash (Fig. 4c) to create a roof-like structure to support the soil and turves placed on top so that cavities would remain within the adder bank. Reed bundles and larger timbers were placed along the south-facing edge to ensure access points were maintained once the bank was covered with topsoil, which originated from digging a shallow dyke adjacent to the bank. Large timbers were also placed at right angles to the bank alignment to support longitudinal timbers to further maintain/provide access points. Over time, as the logs and brash decompose, the bank will collapse to some degree, but additional niches will also be created as a result of bank movement. The bank was covered with spoil from a shallow dyke excavated adjacent to the adder banks (Fig. 4d). Topsoil and turves were placed on the bank to aid vegetation establishment, whilst the borrow pits vegetated quickly and provided ephemeral habitats for amphibians and invertebrates. The final stage was to expose the timbers, brash and reed bundles placed along the front edge of the adder bank to create access points (Figs. 4f, 4h). This was initially undertaken by a 360° excavator (Fig. 4e) and then by hand using spades.
