Designing a new access point for lesser horseshoe bats, Gloucestershire, UK

Paola F. Reason^{1*}

¹Arcadis Consulting (UK) Ltd. The Mill, Brimscombe Port, Brimscombe, Stroud, GL5 2QG, UK

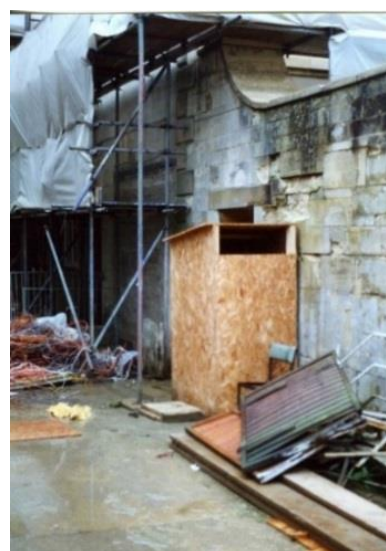
Figure 3. Initial chute design (implemented in 2000). The photograph shows a temporary chute (initial design), the doorway (just visible behind chute) leading to the steps down into the basement, and the courtyard (garden) wall. The boiler house is behind the photographer (photo taken prior to work on the new kitchen extension).

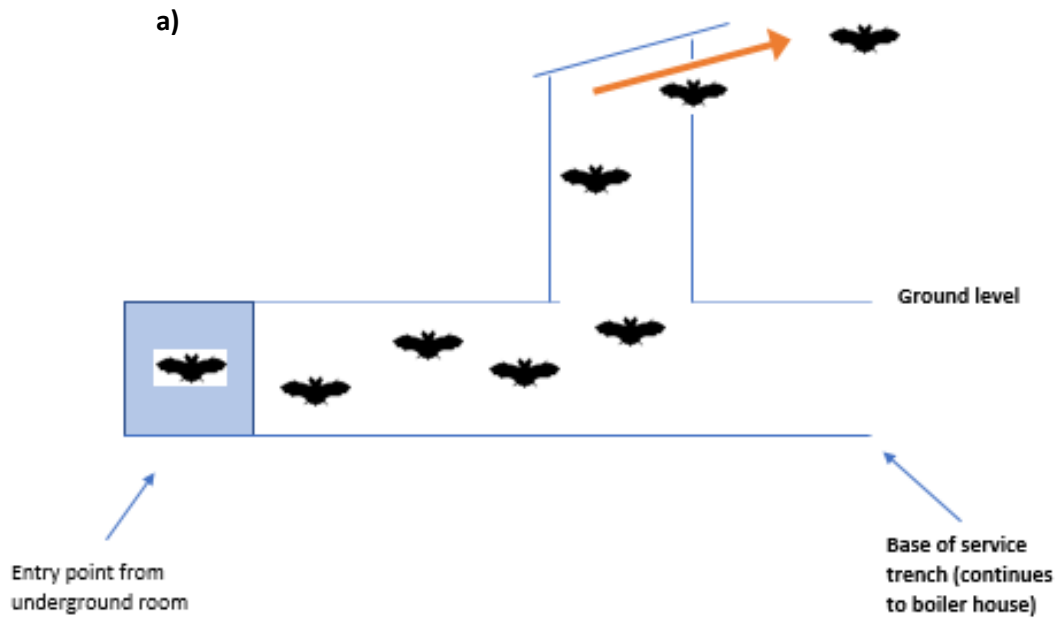
Figure 4a. The vertical chute design, above the service trench. Bats had to negotiate a 90° turn to enter the service trench at the point shaded blue, and again at the base of the chute. Bats used this design to exit but not re-enter. One of the unsuccessful modifications was to create an access gap at the rear of the chute.

The bats used the vertical chute to exit, but would not use it to return, even after several minor modifications. These included: creating a matching access gap at the rear (to allow the bats to enter from either side); painting the chute with horseshoe bat droppings from the roost made into a slurry to make the exit route smell of bats; throwing in dry droppings for the same reason; and lining the chute with egg boxes to change/improve the way echoes were ‘perceived’ by returning lesser horseshoe bats.

The chute entrance was bigger than the minimum size specified for lesser horseshoe bats (Mitchell-Jones & McLeish 1999), and they were readily using the new flight-path to exit the roost, so it was clearly navigable in principle. However, they did not return to their roost via the vertical chute.

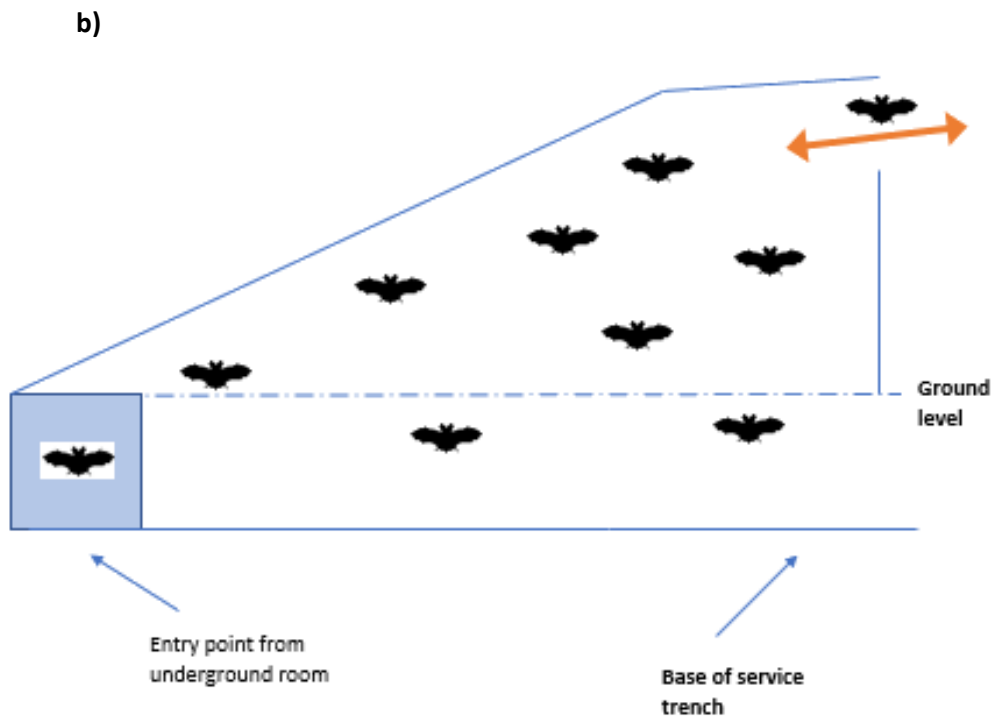
Figure 4b. The line of the new sloped chute design. Bats have a clear line-of-‘sight’ through to the basement. The two 90° turns (see Figure 2) were ‘softened’: firstly, by enlarging the link between the underground room and the service trench by removing a section of wall; and secondly, by significantly modifying the shape of the chute. Bats exited and re-entered this design of chute.

The return journey required the bats to drop down then navigate a 90° bend; it was considered possible that the echolocation signals produced by the chute’s shape did not allow the bats to sense a way through. The chute was therefore substantially modified (Figure 4b and Figure 5) to give the bats a clear ‘line of sight’ through the structure (the sharp bend between the service trench and the basement was also enlarged to ‘soften’ the turn). Full modification of all of the components of the chute and flight-path took several months, and the first full trials did not take place until September 2001.

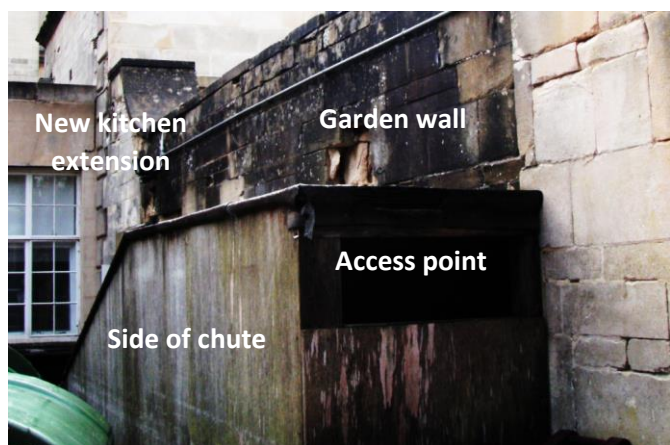
Figure 5. Current chute in place (after several years).

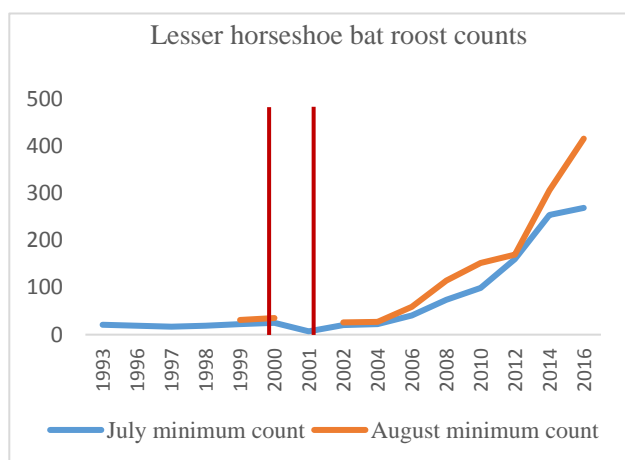
Figure 6. Lesser horseshoe bat roost counts (for raw data see Table 1). For the earliest counts (1993-2000), the maximum count recorded in the period May-July is plotted. The red lines show the period of intervention.

Bat numbers: The roost has remained *in situ* throughout the period. The colony, which numbered around 20 prior to construction, and dipped to below ten individuals during construction, now comprises several hundred individuals (Table 1 and Figure 6).

Column 2 identifies the source of the data. Where there was more than one count in May to July, the highest count achieved was plotted in Figure 6.
