Effectiveness of mitigation of the impacts of a new road on horseshoe bats *Rhinolophus ferrumequinum* in Wales, UK

SUMMARY

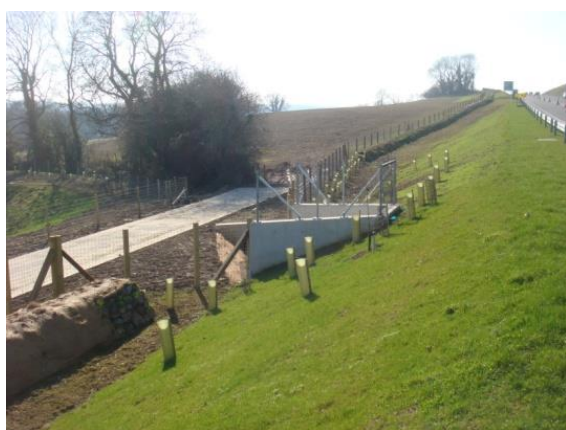
Figure 2. Culvert 10, showing line of trees (known horseshoe bat flight-line) leading towards southern entrance, marked by white wing-walls. Tree guards indicate the planting around back and sides of the culvert to guide bats into the structure.

There are also lessons to be learnt from the results for Culverts 5, 7 and 10, which were used less than other crossings. This was most likely due to their size and positioning within the surrounding landscape, as well as the availability of linear features to guide bats to the headwall. All three culverts were smaller than the other mitigation measures and suffered from sub-optimal linkages to strong linear features, along which the bats might be expected to be moving.

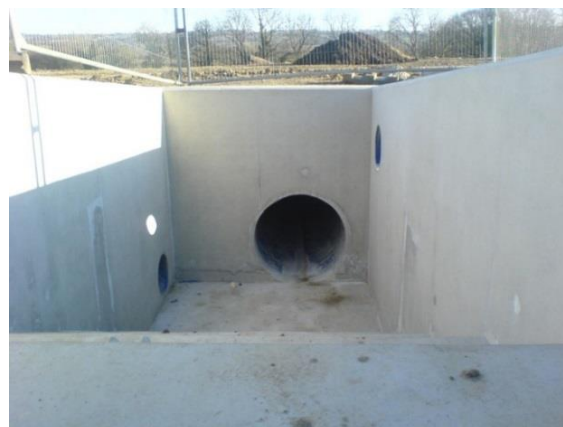
Figure 3. Culvert 5, a 1.5 m diameter drainage ring (with steps leading down into the entrance for otters).

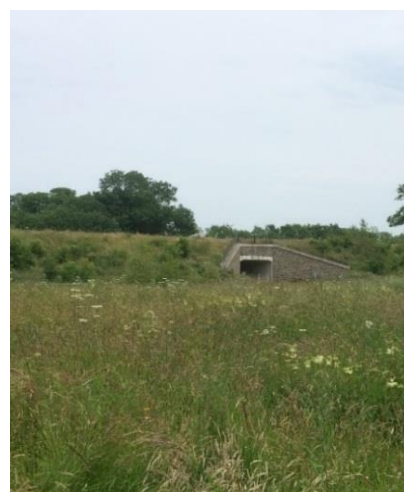
**Figure 5.** Southern entrance to Sunnyside Underpass (for cattle), located within a retaining wall created within the road embankment to avoid loss of habitat from Sunnyside Wood.

Sunnyside Underpass (Figure 5)	2660 x 2370 mm cattle underpass	Positioned within large embankment perpendicular to occasional commuting route alongside Sunnyside Wood. Landscape planting likely to improve the link over time. Approximately 5.6 km from roost
Eastern Underpass	3500 x 4000 mm equestrian underpass	Located approximately 70 m east of Eastern Cleddau river and 20m north of Narberth Brook (both used as significant commuting routes by greater horseshoe bats), though lacking clear linear links to either entrance. Approximately 4.3 km from roost
Western Underpass (Figure 6)	3500 x 4000 mm equestrian underpass	Located 15 m west of Eastern Cleddau river (a significant commuting route by greater horseshoe bats) and adjacent to Essential Mitigation Area 1, one of four specially created foraging habitat areas along the Scheme. Approximately 4.3 km from roost.
Woodford Lane Bridge	Open span bridge: 8950 x 3500 mm	Located on sunken lane running underneath the Scheme, used as occasional commuting route by greater horseshoe bats. Approximately 5.9 km from roost

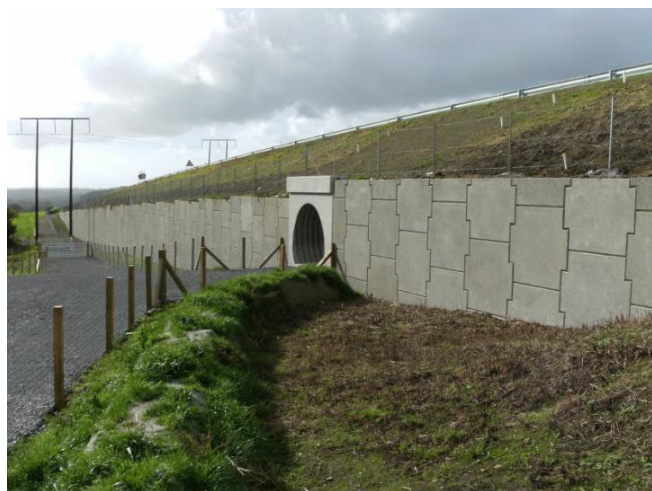
**Figure 6.** The Western underpass, showing the wet grassland habitat of Essential Mitigation Area 1, adjacent to the southern entrance. The new road runs along the top of the embankment.
