## Performance of artificial maternity bat roost structures near Bath, UK

### SUMMARY

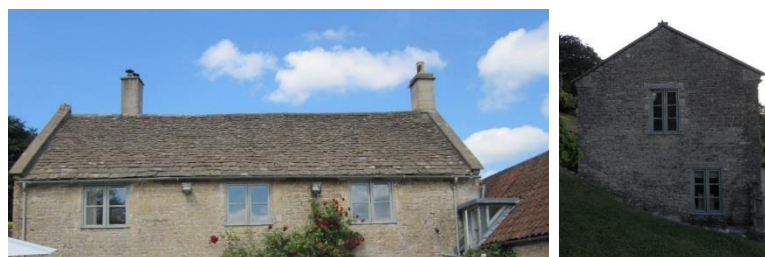
**Figure 1.** A brown long-eared bat maternity roost was originally present in the inhabited former farm house loft void (image left), while a common pipistrelle maternity roost was present in the cavities/crevices of an adjoining stone constructed cottage wall (image right).

A brown long-eared bat maternity roost was identified in the loft of the inhabited former farm house, and a common pipistrelle maternity roost was found in an east-facing stone constructed gable wall (triangular portion of a wall between the edges of intersecting roof pitches) of an adjacent uninhabited cottage (Figure 1). There were at least 8-12 brown long-eared bats (two individuals recorded with pups) and 76 common pipistrelle bats. These are the two species most frequently encountered in households by Natural England (the government adviser for the natural environment in England) roost visitor volunteers according to records collated from 2013 (National Biodiversity Network 2017). A lesser horseshoe bat *Rhinolophus hipposideros* and greater horseshoe bat *Rhinolophus ferrumequinum* night roost was also found within a nearby carport structure.

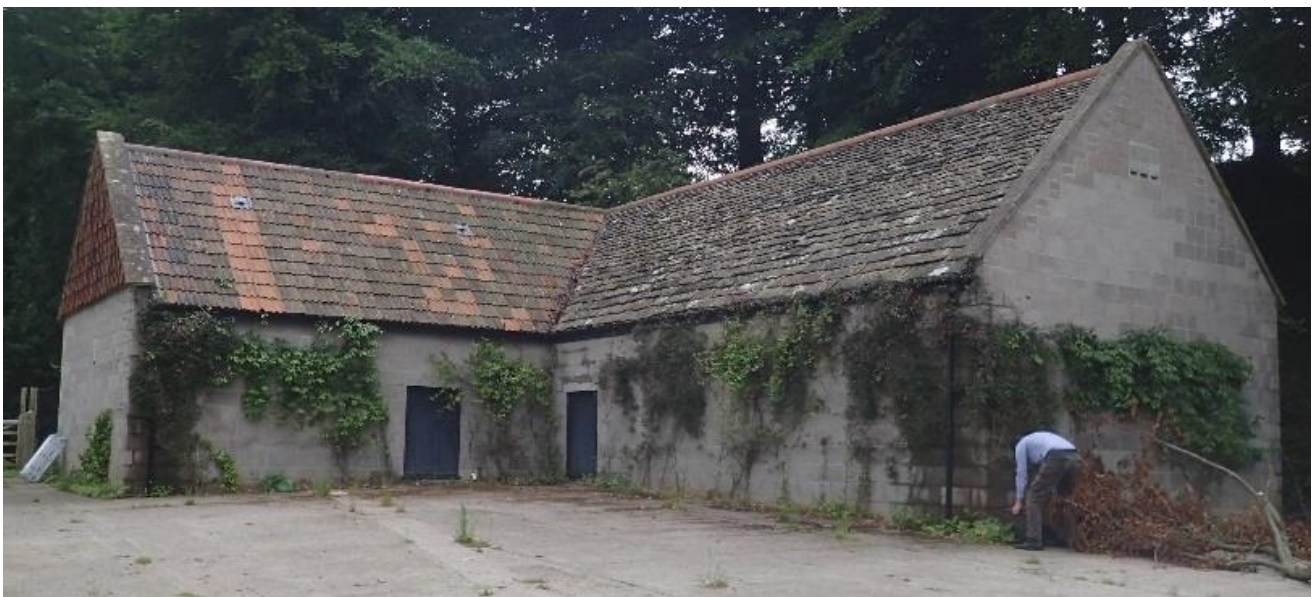
**Figure 2.** New purpose-designed 'L' shaped Bat House including a sloping gable roof (longest section is east-west aligned); visible roost features include bat tiles, ridge beam access points, wall-integrated 2FR Schwegler Bat boxes, hanging tiles, and wall mounted climber planting.

- A Bat House with the primary purpose of attracting void-dwelling brown long-eared bats (Figure 2).
- A Bat Wall with the primary purpose of attracting crevice-dwelling common pipistrelle bats (Figure 3).

| Design feature | Bat House |
|--|--|
| Shape | <ul style="list-style-type: none"> <li>• Single storey windowless structure with a sloping gable roof.</li> <li>• ‘L’ shaped building arrangement replicates the original roof/loft space and associated microclimatic variations (Figure 2); longest section east-west aligned.</li> <li>• Ground floor partitioned into two compartments including a Bat Summer Roost and a Horseshoe Hibernation Roost, covering a third and two-thirds of ground-floor area respectively.</li> </ul> |
| Dimensions | <ul style="list-style-type: none"> <li>• Length 15 m and 12.5 m (two length measurements given because loft is ‘L’ shaped); height 2.25 m; width 6 m.</li> <li>• Loft void slightly larger than the original as the former contained water tanks, chimneys and trusses, all of which inhibited open flying space favoured by brown long-eared bats.</li> </ul> |
| Access points and specific roost features for brown long-eared bats within loft void | <ul style="list-style-type: none"> <li>• 5 access gaps at the eaves and 10 ridge tile access points; each hole 15-20 mm (high) x 20-50 mm (wide) (Figure 2).</li> <li>• Timber framework of loft provides key roost features for brown long-eared bats.</li> </ul> |
| Access and roost features for other bats | <p>Interior features:</p> <ul style="list-style-type: none"> <li>• 11 lattice-like bricks (holes c. 20 mm [wide] x 60 mm [high]) on the interior walls (ground floor and Loft House) for crevice-dwelling bats.</li> <li>• 8 rough-surfaced timber boards bolted to the wall leaving a 20-25 mm enclosed bat roost space between the board and wall; board dimensions ca. 30 cm x 30 cm.</li> <li>• Four rough untreated timber baffles installed on the walls for bats to hang from; dimensions – 5 m x 0.1 m x 0.1 m.</li> <li>• Cavity wall installed on one gable end of building.</li> </ul> <p>Exterior features:</p> <ul style="list-style-type: none"> <li>• Ivy and other climbers planted up the external walls to serve as night perches (Figure 2).</li> <li>• 9 Schwegler 1FR and 3 Schwegler 2FR Modular bat boxes embedded into outside walls at varying heights between 2.5 m and 4.5 m to attract various bat species; potential to be used for maternity or hibernation (Figure 2).</li> <li>• Ten bat tiles installed in the tiled roof allowing access beneath tiles and roofing felt (Figure 2); access into the loft space provided via cut sections in the roofing felt.</li> <li>• Hanging tiles installed on the north and east facing walls (Figure 2).</li> </ul> |

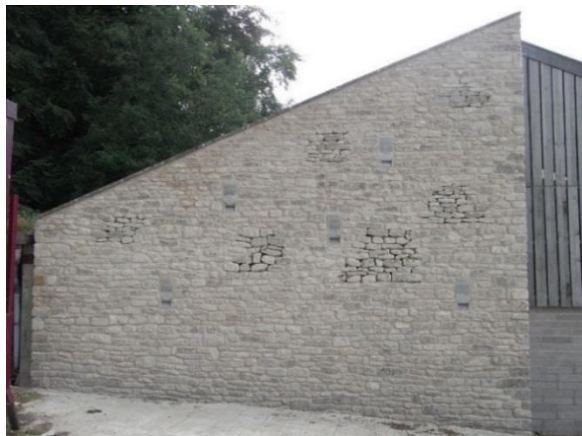
**Figure 3.** New purpose-designed Bat Wall constructed on the east-facing gable wall of an existing hay barn; includes multiple crevices between the stonework leading to internal cavities and five wall integrated IFR Schwegler Bat boxes.

| Design feature | Bat Wall |
|---|---|
| Aspect & dimensions | <ul style="list-style-type: none"> <li>• East-facing.</li> <li>• Depth 0.45-0.60 m; Width 8 m; Height 3-7 m (dimensions approximately replicate the dismantled wall previously occupied by common pipistrelles).</li> </ul> |
| Roost features | <ul style="list-style-type: none"> <li>• Multiple crevices installed between the stone work with access dimensions of 15-20 mm (high) and 20-50 mm (wide); these are of similar size to those that were being used by the bats within the original wall roost (Figure 3).</li> <li>• 5 artificial wall integrated bat boxes (1FR Schwegler) (Figures 3).</li> <li>• The thickness of the new wall has allowed for the creation of an insulated void space (connected to the crevice entrances) near the rear wall heaters.</li> </ul> |

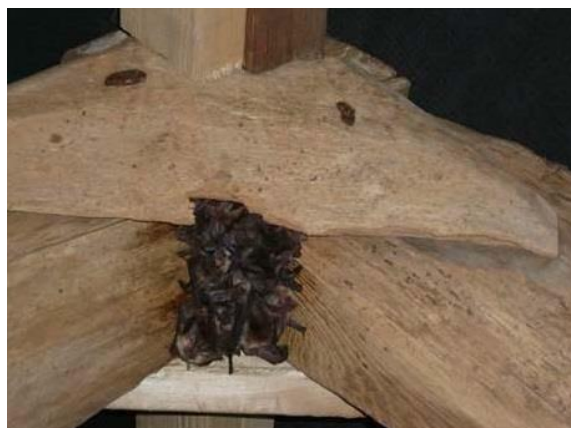
**Figure 4.** Probable brown long-eared bat maternity roost in the roof void of the Bat House of 20-25 individuals (2013).

The results of the monitoring to date are summarised in Table 5. Roosting brown long-eared bats and/or fresh brown long-eared bat droppings were observed each year from 2012, with observed numbers peaking at 20-25 individual bats in August 2013 (Figure 4). No clearly identifiable juveniles were observed. While observed brown long-eared bat numbers were lower in 2014-2017 (Table 5), during each visit substantial numbers of fresh droppings / dropping clusters were recorded (up to c. 1000+ droppings). During the last two years the strong distinctive odour associated with a well-used roost was also evident.

The monitoring revealed that brown long-eared bats probably first colonised the roof void of the Bat House in the latter half of 2012 (approximately 18 months after the structure was completed) and were then present annually until spring 2017, at least outside the hibernation season. The large number of droppings, distinctive odour and the regular presence of bats (up to 20-25 in summer 2013) indicate that a brown long-eared bat maternity roost has probably re-established.
