Using clay drain seals to assess the use of dry culverts installed to allow mammals to pass under the A1 trunk road, Northumberland, England

SUMMARY

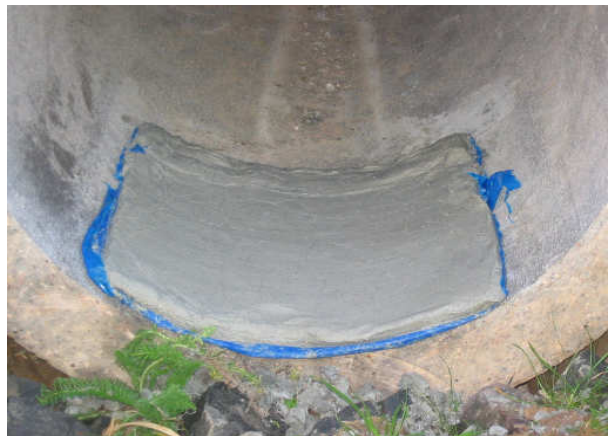
Figure 1. Installation of a clay drain seal at the entrance to a dry culvert (Photo: Dorian Latham)

monitoring was not practical. Clay pads placed in rafts have been used as a non-invasive means to determine the presence of American mink *Mustela vison* on watercourses (Reynolds, Short & Leigh 2004). The raft uses a clay pad to record footprints. For the current study, it was decided to use clay-based drain seals (45 x 45 cm x 0.5 cm thick) placed at the entrances to three dry culverts (Fig. 1). Drain seals are used in pollution control to close drains in the event of a pollution incident. The seals are available from a number of suppliers (suppliers for this study were: Clean Innovations, Greenhill Mill, Colne, Lancashire, UK) and cost approximately £100 for a pack of four.

The clay drain seals were checked at least weekly during the trial period, 28 August to 26 October 2007. As animals cross the clay pad an imprint of their tracks is left. At each visit any evidence of animal tracks was recorded, the pad was photographed, and then thoroughly wetted and smoothed to remove any tracks and leave a clean surface to record any subsequent tracks. Tracks left on the pad were identified using an animal track key (Bang & Dahlstrom 2006).

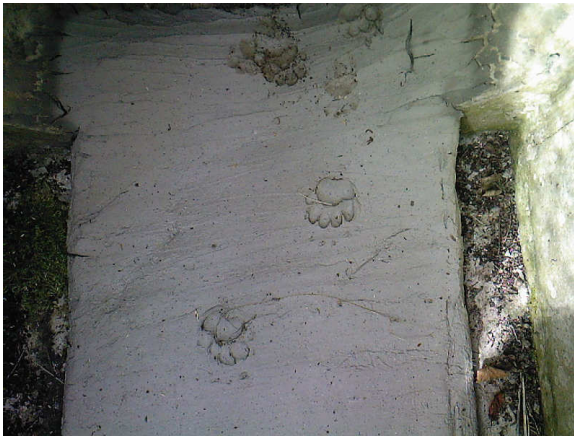
Figure 2. Badger tracks recorded on a clay drain seal (Photo: Dorian Latham)

Badger prints (Fig. 2) were recorded frequently on the pads showing 'upstream' and 'downstream' movements, this concurring with the general conclusion of previous studies that badgers are reasonably acceptable of many underpass types (Anderson 2003). The dry culverts were also used by other mammals demonstrating that these structures provide an opportunity for passage by mammals that could otherwise be restricted by even low river flows.

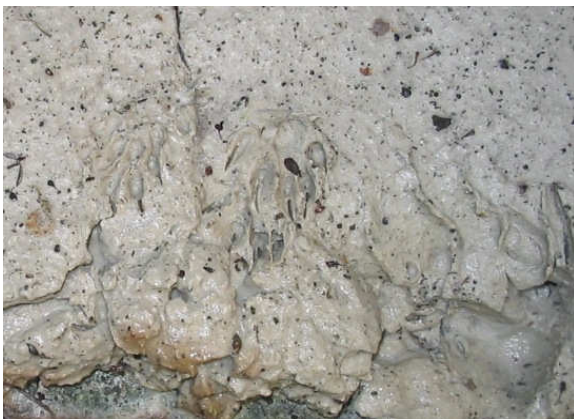
Figure 3. Mink (left) and badger tracks recorded on a clay drain seal (Photo: Dorian Latham)

The study has confirmed the presence of American mink (Fig. 3) on the Back Burn (a tributary of the River Coquet); this non-native species is known to be present throughout Northumberland.
